Attachment A: Pre-CERCLA Screening Checklist/Decision Form

Site Name: Vasquez Boulevard / Interstate 70 Superfund Site - 2424 East 40th Ave.
 Other Site Name(s): 39th Greenway Drainage Project

Appendix 1 - Pre-CERCLA Screening
VB/I-70, 2424 East 40th Ave., Denver
July 2019

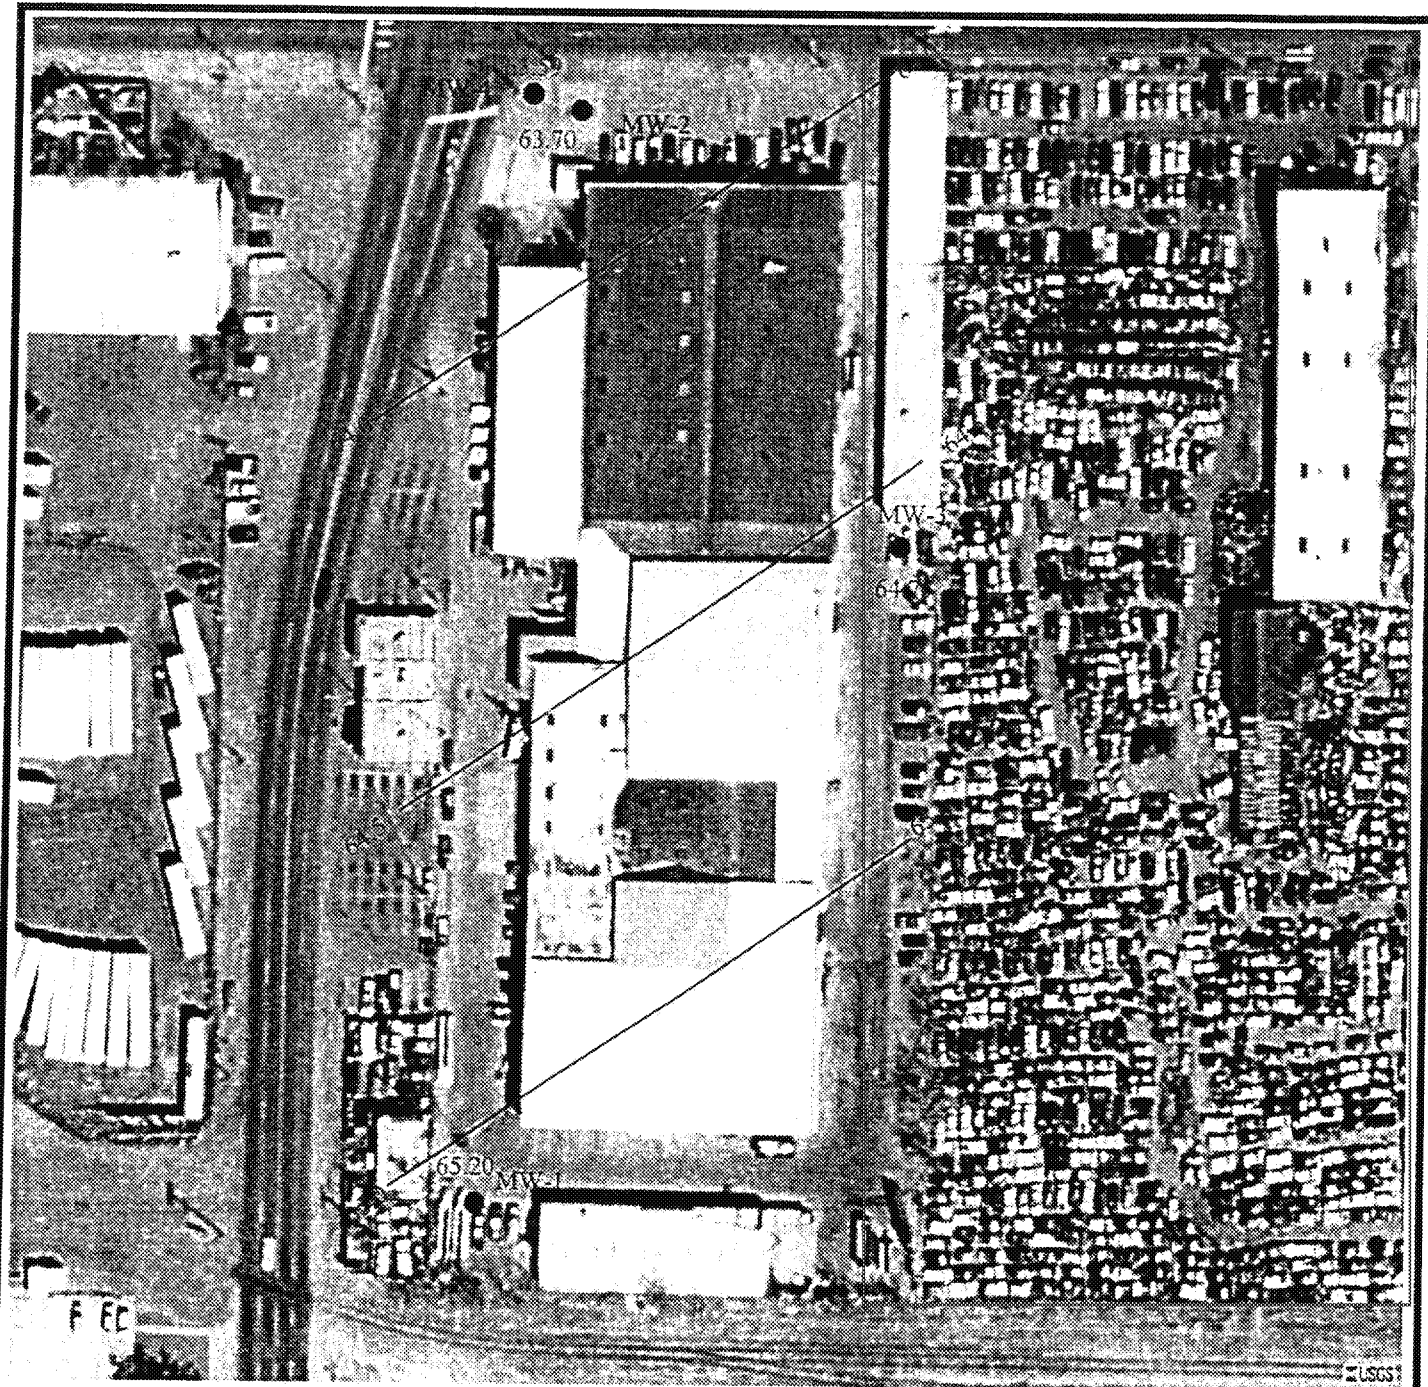
Figure 2: Groundwater Flow Direction
2424 East 40th Avenue Site
Pre-CERCLA Screening

SITE MAP

PHASE II SUBSURFACE INVESTIGATION

HARDING GLASS FACILITY
2300 EAST 40TH AVENUE
DENVER, COLORADO 80205

Based on drilling logs from Talus' Phase II ESA, the majority of the subsurface in the area is sand and silt. There are also relatively thin layers of clay with gravel interbedded in the sand and silt. At approximately 90' below ground surface (bgs), bedrock is encountered. Bedrock underlying the site is from the Denver formation and consists of claystone. During investigations, groundwater was encountered between 34' and 37' bgs. Groundwater flow is to the northwest (Figure 2).
